TECHNICAL BULLETIN 02

PRODUCT: T200 Thruster with pre-installed penetrator (T200-THRUSTER-BROV2-CCW-R1-RP, T200-THRUSTER-BROV2-CW-R1-RP, T200-THRUSTER-BROV2-SPARE-R1-RP)

SUBJECT: Poor adhesion of potting on T200 Thrusters with pre-installed cable penetrator.

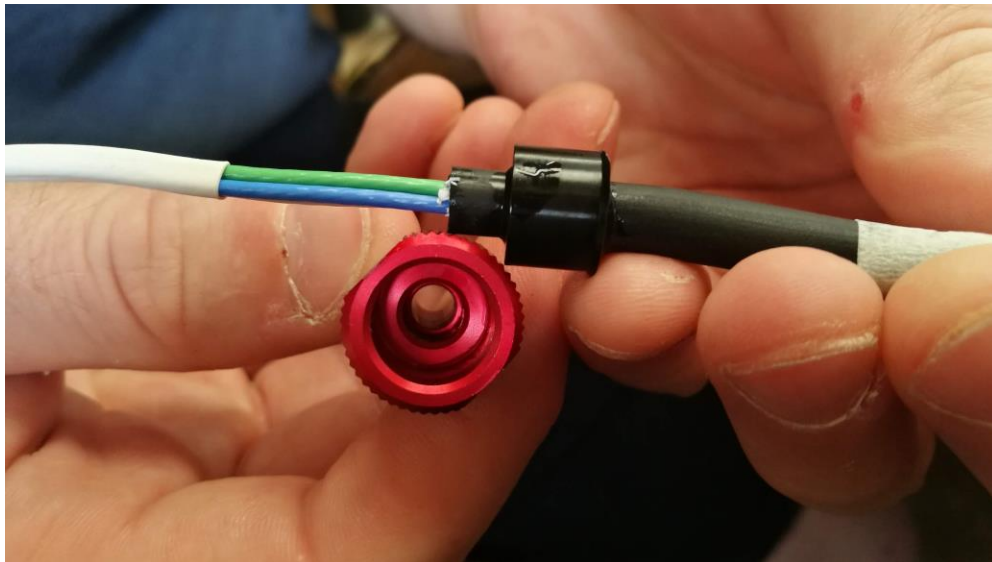
SUMMARY: On a small number of pre-potted cable assemblies (estimated 1 out of every 1000 cables Blue Robotics manufactures), it has been found there is poor adhesion to the aluminum for undetermined causes.

These affected cables will not seal properly and have been found to pop out of penetrators when gently tugged.

Figure 1. Cable Penetrator with poor adhesion to aluminum cable penetrator.

CUSTOMER ACTION: If you have an affected cable, please use the below contact information to begin the RMA process and receive a replacement thruster.
