## **TECHNICAL BULLETIN 13**

**DATE:** 06 December 2024

- Ping360 Scanning Imaging Sonar (BR-100399)

**SUBJECT:** Acknowledgment of Product Issue – Ongoing Investigation

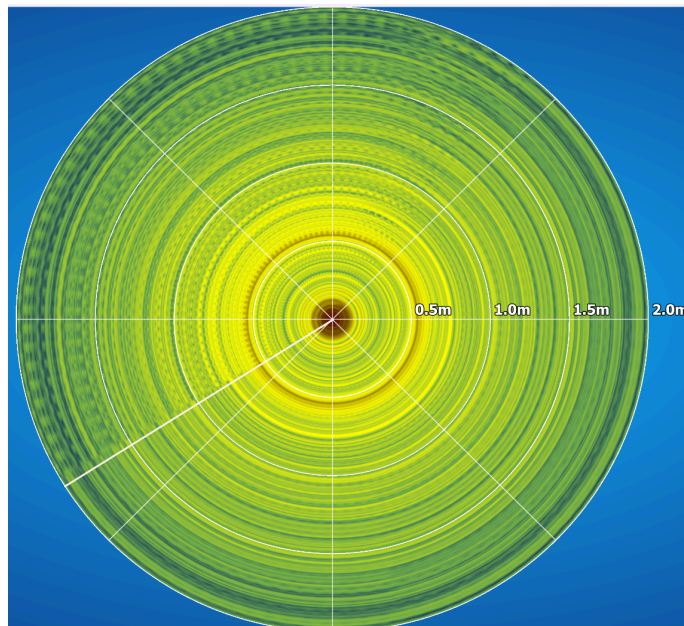
**SUMMARY:** A report was submitted informing Blue Robotics that three sonars did not perform as expected at certain depths that remain within the product’s specified depth rating. Blue Robotics has successfully replicated the issue. We are actively investigating the root cause; however, we do not have a confirmed solution or corrective action to address the issue. We assure you that resolving this matter is a top priority and does not impact all sonars or lead to leaks to connected devices.

**IDENTIFICATION:** The Ping360 stops working, or the PingViewer image becomes “smeared” when submerged to significant depth and functions normally in shallower depths. PingViewer smears:

**CUSTOMER ACTION:** Submit a [support ticket](#) reporting the problem.

**BLUE ROBOTICS ACTION:** We will replace the unit once the problem has been resolved or RMA the sonar and issue a refund. We deeply regret any inconvenience this issue may cause and sincerely appreciate your patience and understanding as we work toward a resolution.
