## **TECHNICAL BULLETIN 05**

**PRODUCT:** Lumen Subsea Light, Lumen Subsea Light Pre-Connected Sets (LUMEN-LIGHT-R2-RP, LUMEN-PAIR-R2-RP, LUMEN-QUAD-R2-RP)

**SUBJECT:** Severe cracking in Lumen lenses.

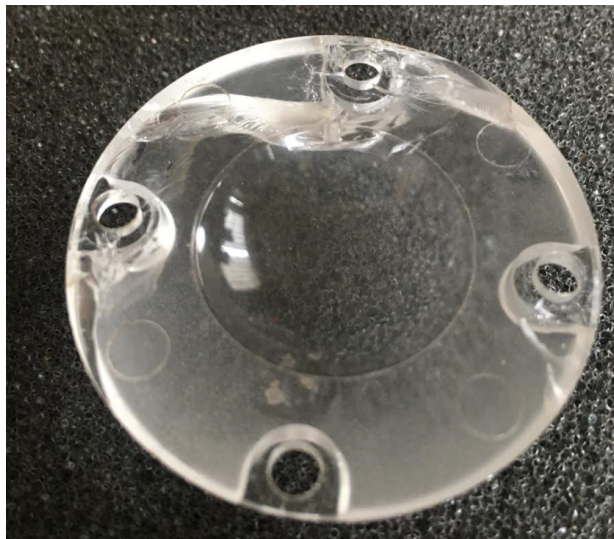
**IDENTIFICATION:** Blue Robotics recommends inspecting all Lumens from orders shipped between March - April 2021 for cracking in the lenses. These cracks typically pass through areas adjacent to the screw holes and propagate through critical sealing areas, see figures 1 and 2 below.

Figure 1. Large crack close to screw mounting holes

**CUSTOMER ACTION:** If you have any affected lenses, please contact our support team at [support@bluerobotics.com](mailto:support@bluerobotics.com) with all available order information to receive replacement lenses.

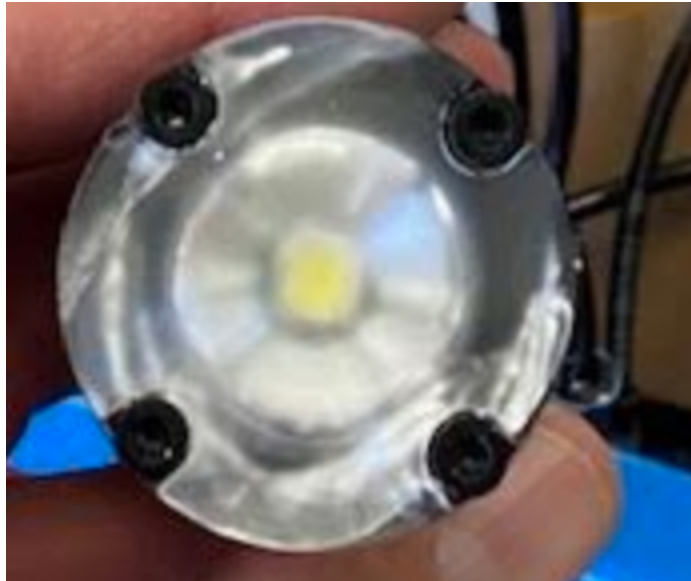
Figure 2. Cracks propagating throughout sealing areas.
