TECHNICAL BULLETIN 07

DATE: 05 December 2022

- Blue Robotics Ethernet Switch (ETHSWITCH-R1-RP)

SUBJECT: Ethernet Switch populated with incorrect crystal oscillator

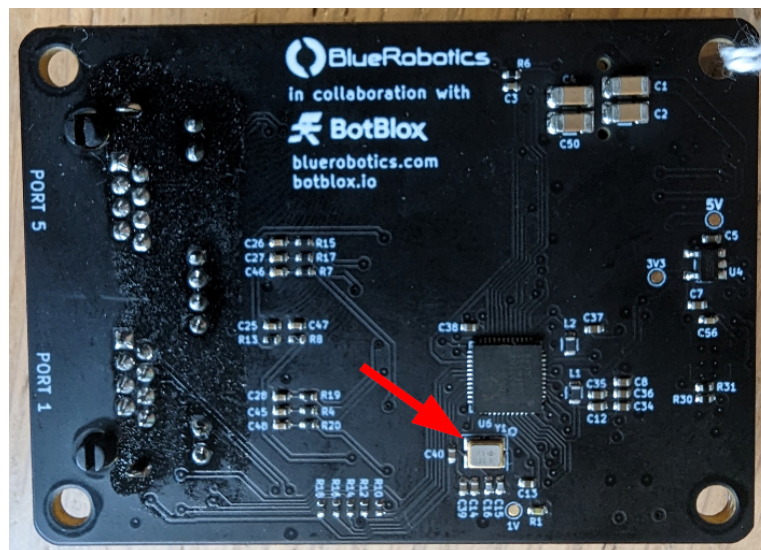
SUMMARY: In early November, customers reported connectivity problems while using the Ethernet Switch. After investigation, the problem was isolated to the crystal oscillator. Due to a component sourcing mistake, Ethernet Switch PCBs were populated with an incorrect crystal oscillator. This renders the switches nonfunctional.

Figure 1. Location of affected crystal

CUSTOMER ACTION: If you have any affected Ethernet Switches, please contact our support team at support@bluerobotics.com with all available order information to receive replacement boards when available.

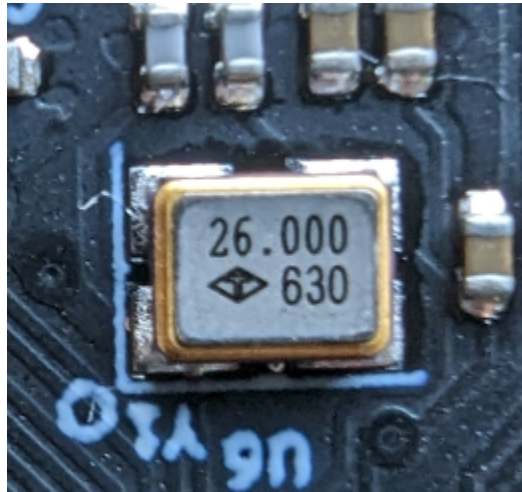
IDENTIFICATION: Blue Robotics recommends visually inspecting all Ethernet Switches from orders shipped between late September to November 2022 for the incorrect crystal component. Figure 1 shows the location of the crystal oscillator on the back of the switch. The correct crystal is labeled “25” and the incorrect crystal is labeled “26.000” as shown in Figure 2.

Figure 2. The incorrect crystal is labeled “26.000”
