TECHNICAL BULLETIN 03

PRODUCT: Products with pre-installed potted penetrators

SUBJECT: Poor adhesion of potting on components and devices with pre-installed cable penetrator.

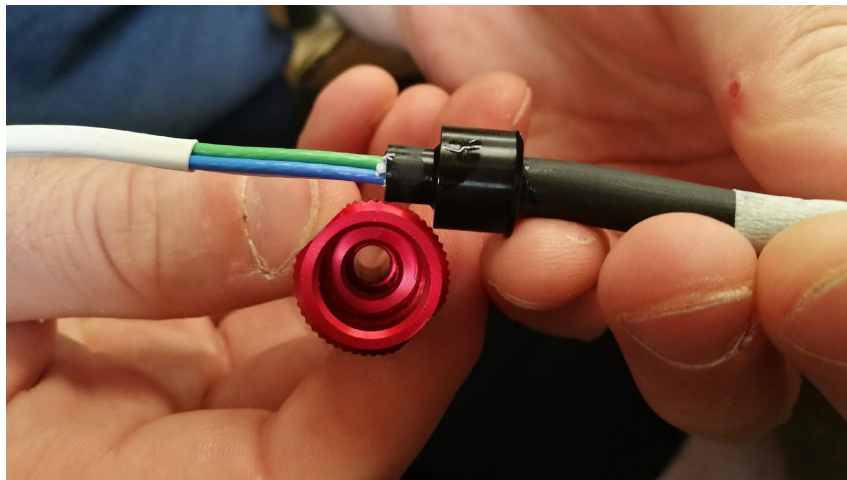
Figure 1. Cable Penetrator with poor adhesion to aluminum cable penetrator.

CUSTOMER ACTION: If you have an affected cable, please use the below contact information to begin the RMA process and receive a replacement component. Higher value products, such as the Ping360, will need to be returned before a replacement can be sent.

BLUE ROBOTICS ACTION: The cause of the delamination between the penetrator and the epoxy has been narrowed to either inconsistencies in the penetrator anodization process, atmospheric conditions, inconsistencies in the epoxy that we are using, or a combination of the three.

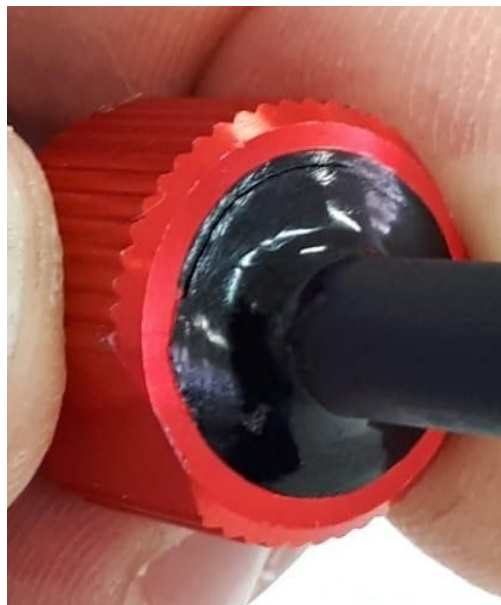
Figure 3. Cable Penetrator with poor adhesion to aluminum cable penetrator.

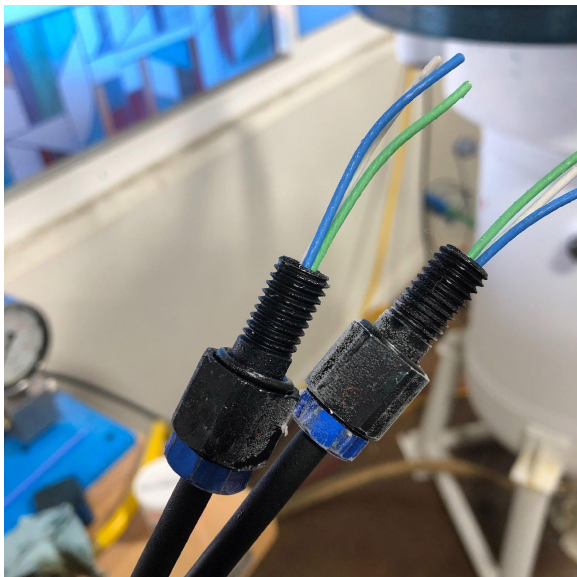
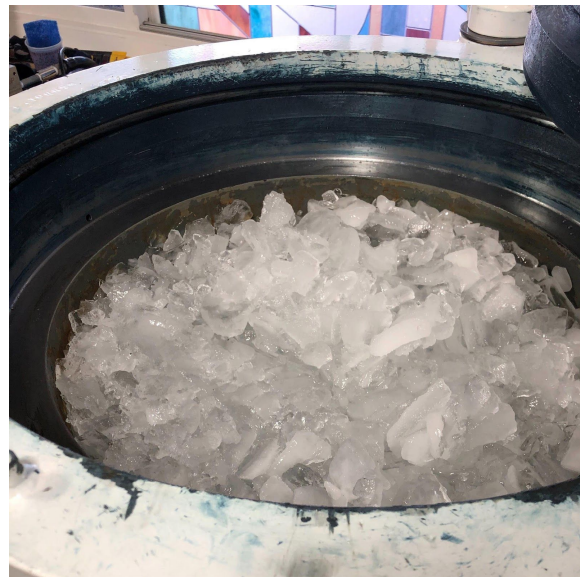
Compression gland penetrator prototypes after $<0^{\circ}\text{C}$ exposure (left) and our pressure test chamber cooled to $<5^{\circ}\text{C}$ for cold water testing (right).

We've already tested several rounds of prototypes with excellent results including cycled pressure testing to 90 bar (the limit of our pressure chamber), high and low temperature exposure, strain on the cable, contaminated sealing surfaces, and with variations in cable diameter. In all cases this new design has performed well. We still have a lot of testing to perform to increase confidence further.
