TECHNICAL BULLETIN 12

DATE: 28 March 2024

SUBJECT: Low-Light HD USB Camera Failures due to mount

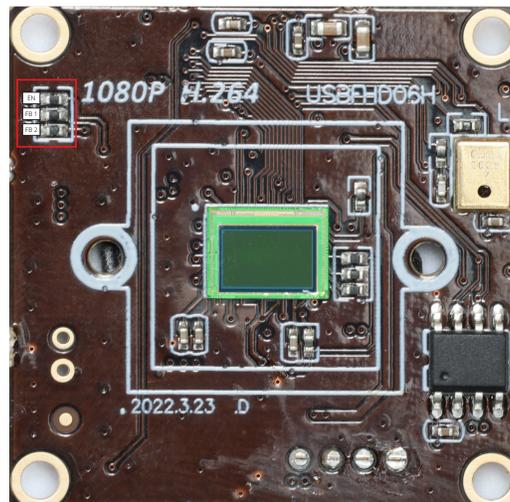
Figure 1: Feedback and enable resistors on new camera revision

Three resistors on the left side of the camera were not accommodated (marked by the red box in Figure 1 above), and as a result, when mounted, the camera would press directly on these (very small) parts. Depending on the torque used to fasten the camera to the mount, some or all of these resistors could crack, leading to the camera's failure. Figure 2 illustrates the mark that these resistors would make on the mount.

CUSTOMER ACTION: Rework the mount and replace the camera as follows:

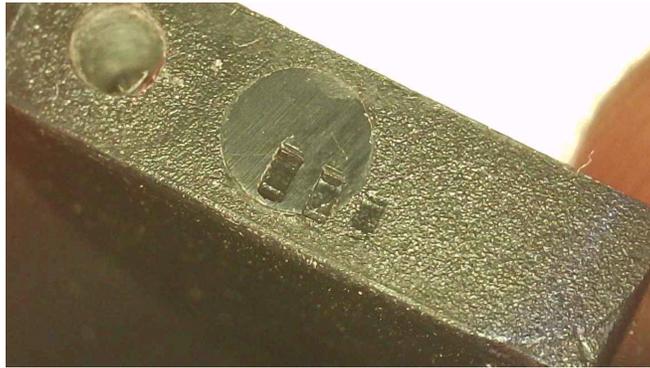
Figure 2: Evidence of the resistor interference on the camera mount

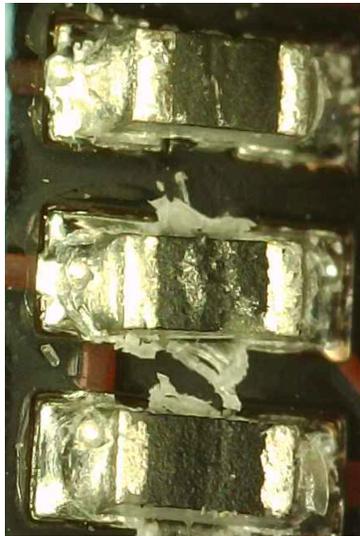
The cracking of the resistors is highly variable and is likely dependent on the installation torque of the screws and variations in the assembly height of the resistors. If the resistors don't crack immediately on installation, it's possible that they could crack at any time due to temperature changes within the ROV enclosure.

Figure 3: Damaged 0402 size 100k resistors reading open circuit

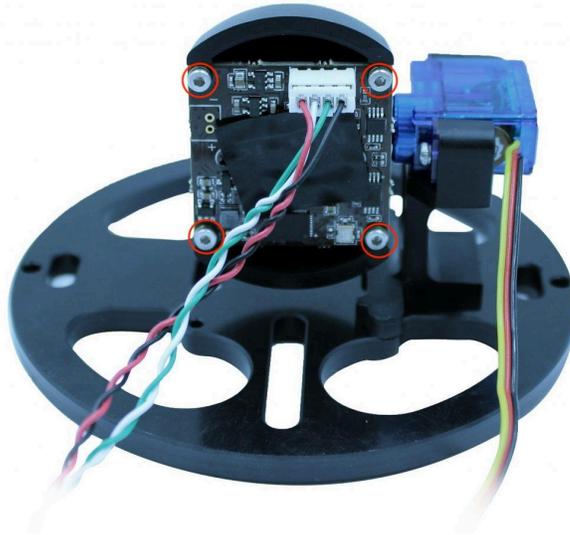
Figure 4. Mounted Camera with mounting bolts identified

1. Use the [support form](#) (problem with a product) to contact the Technical Support team for a replacement camera.
2. Open the electronics enclosure.
3. Unfasten the four camera bolts with a 1.5 mm Hex Driver.

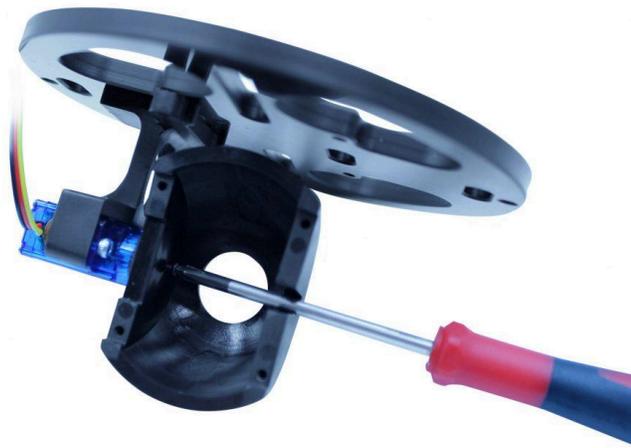
Figure 5: Removing camera mount

4. Unfasten the servo arm screw #000 Phillips Screwdriver (or similar small size) to remove the mount from the servo.

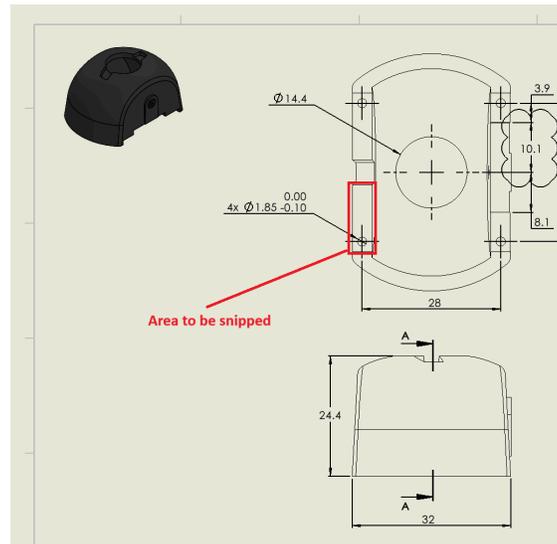
Figure 6: Area to be clipped highlighted on drawing

5. Clip at least 1-2 mm of material from the surface shown in Figure 6 to achieve the result shown in Figure 7, then fasten the camera into the mount with the remaining three fasteners.

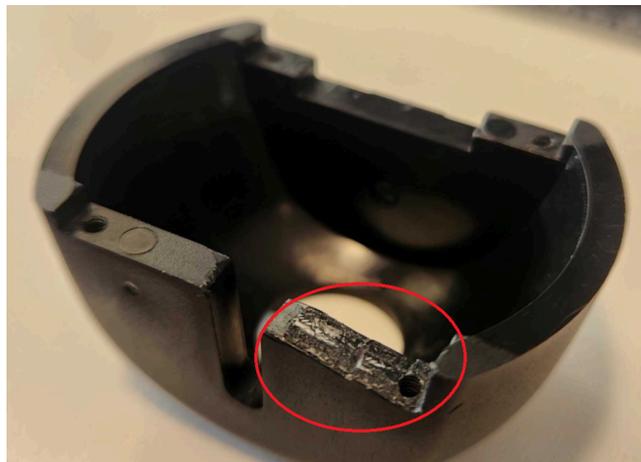
Figure 7: Camera mount after clipping

6. Reinstall the mount on the servo, taking care to mount it in the same position that it was removed from on the servo horn.
7. Replace the camera with a new unit.
